MANAGEMENT OF THE HYDROTECHNICAL TORRENT CONTROL STRUCTURES IN TEN TORRENTIAL VALLEYS LOCATED IN PRAHOVA COUNTY

Anton CĂRĂMIDĂ, Cristian Mihai ENESCU

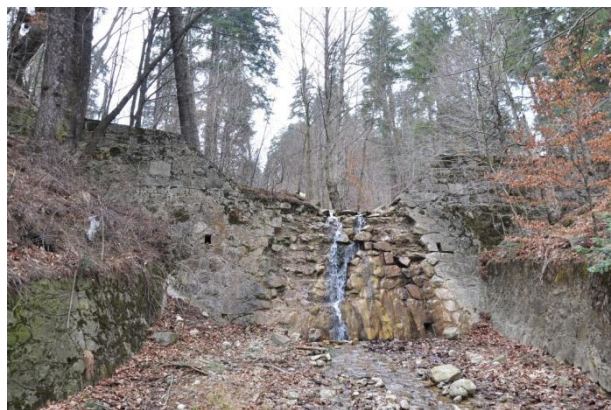
The main identified damages consisted in detachments located in the overflowed area (Figure 1), 58 works being in this situation.

Fig. 1. Dam with damages in the overflowed area

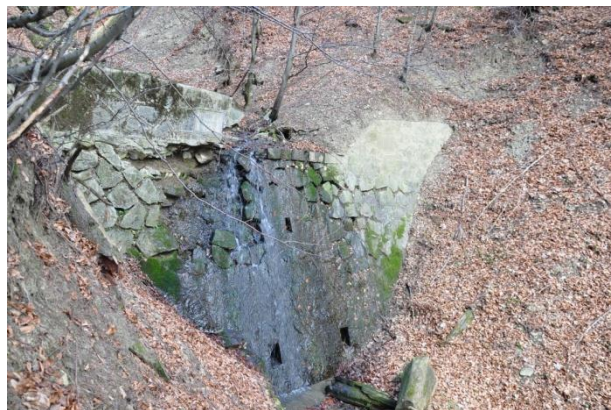
Moreover, approximately 15% of the inventoried structures had detachments also located on the left and on the right of the spillway (Figure 2).

Fig. 2. Damages located to the side of the spillway

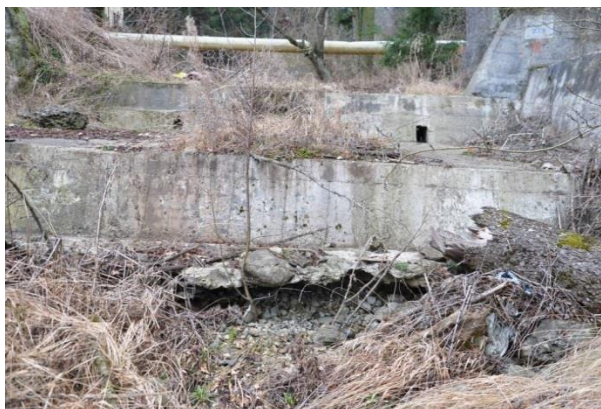
The event of undermining of the body caused damages for 9% of the inventoried works (Figure 3). Undermining of the body was among the most common damages also in the case of Cârcinov River Catchment [16] or in the case of the Upper Basin of the Someșul Mic River [7].

Fig. 3. Undermining of the body of a work

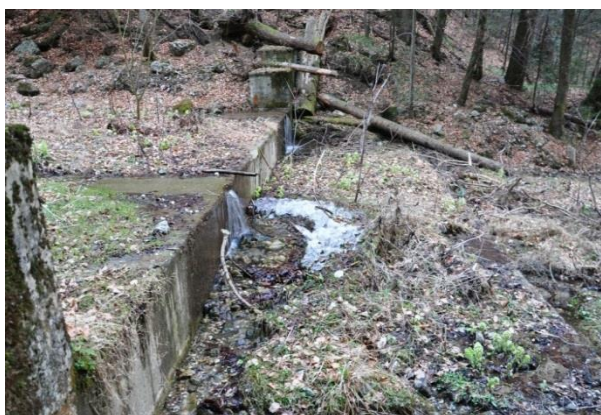
Regarding the identified disfunctionalities, almost three quarters of inventoried works were affected by the clogging in various degrees (ranging generally between 50-70%), located both in spillway and apron (Figure 4). About a third of the works were completely clogged in the spillway and about 15% in the apron.

Fig. 4. Dam with clogging in spillway and in apron

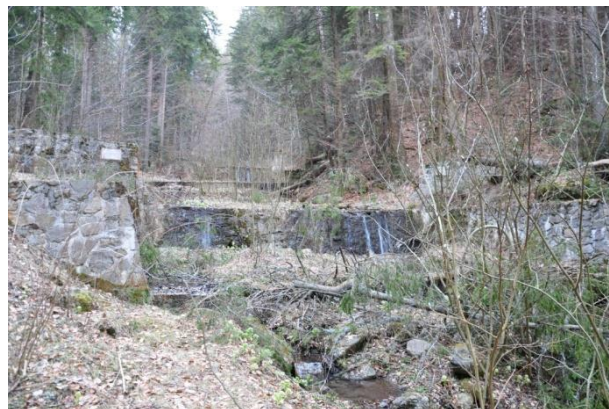
In 52 cases (36%) the forest vegetation was installed both in upstream and downstream of the structure (Figure 5).

Fig. 5. Uncontrolled forest vegetation installed both upstream and downstream of the structure
